**Client:** Cliff Scaffoldings (P) Ltd  
**Job Number:** 10337  
**Project:** Assessment of Right Angle Couplers  
**Test Type:** Slip  
**Test Method:** AS/NZS 1576.2 - 2009 Appendix A

**Test Date:** 4/7/2012  
**Manufacturer's Reference and Batch Number:** 140312INT

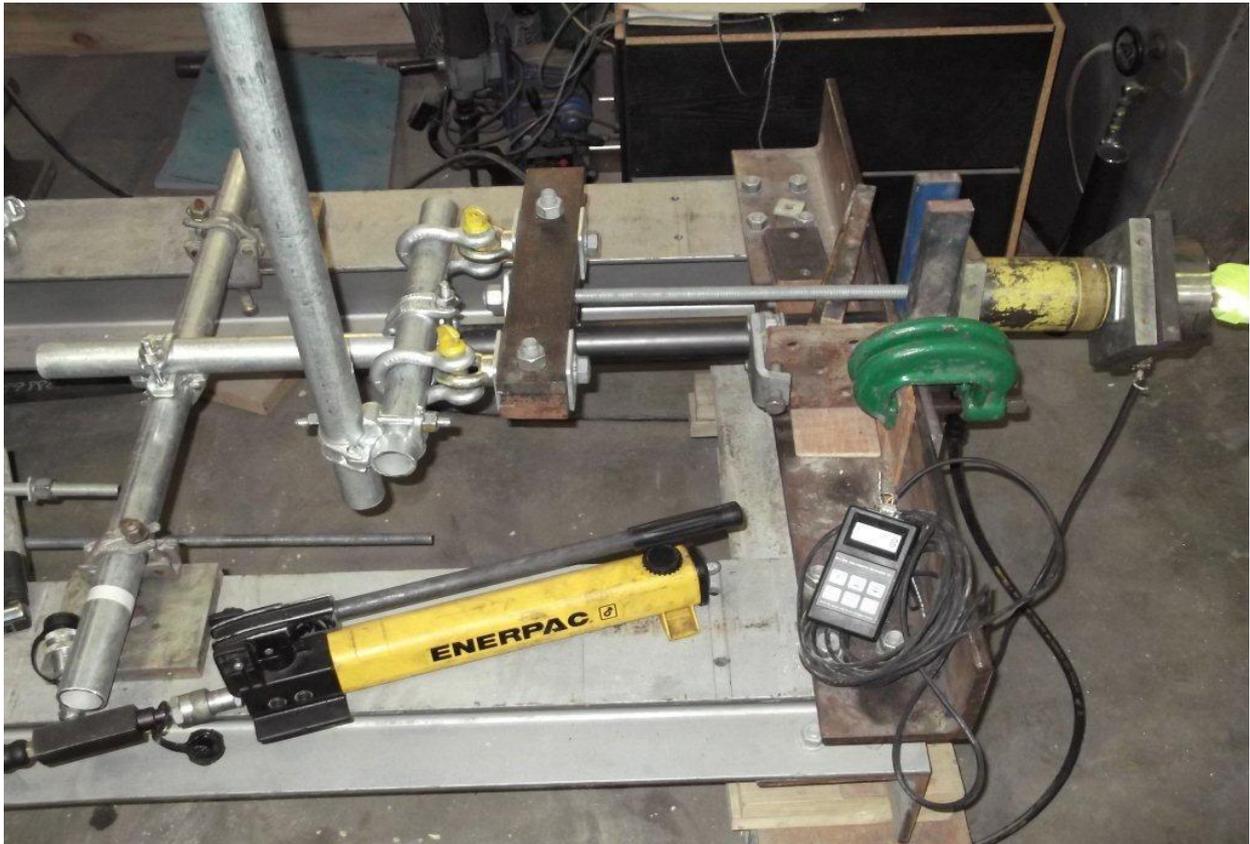
***PHOTOGRAPH 1 - General layout of test apparatus***  
(Note that this is actually the Distortion Test set-up, which is similar)

Methodology: the testing was undertaken in accordance with the Method. Load was applied via an hydraulic ram acting against an electronic digital load cell. Slip was assessed by way of scribed marks on the respective tube component and by use of a steel millimetre rule. Photograph 1 (below) shows the general layout of the test apparatus. Note that the photograph is of the associated distortion test set-up.

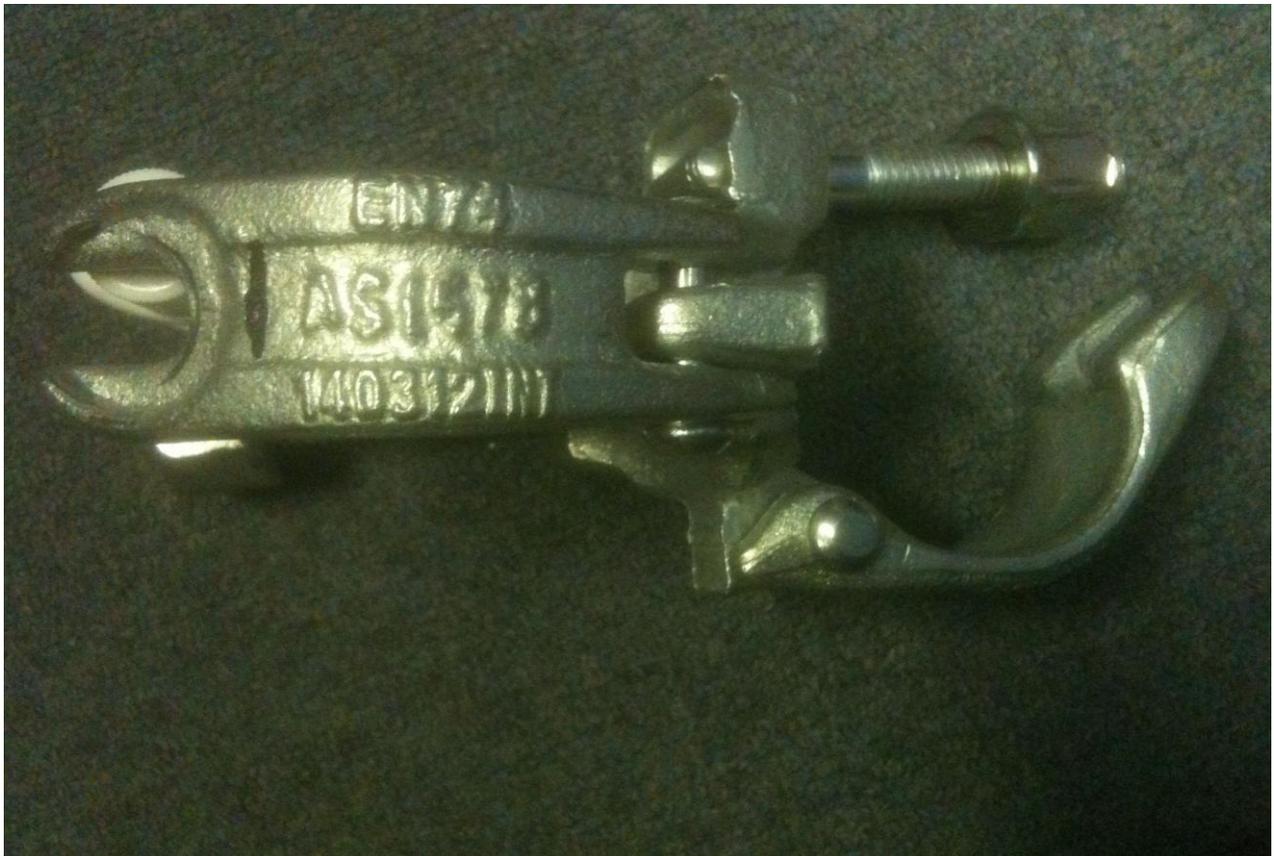
***PHOTOGRAPH 2 - Coupler 1 as tested***
